Notes on a site visit to operations 27<sup>th</sup> February to 3<sup>rd</sup> March 2023 by A. Golding, B.Sc. Hons Geology 400036/96, Pr. Nat. Sci., M.S.A.I.E.G., FGSL, FGSSA.

#### Introduction.

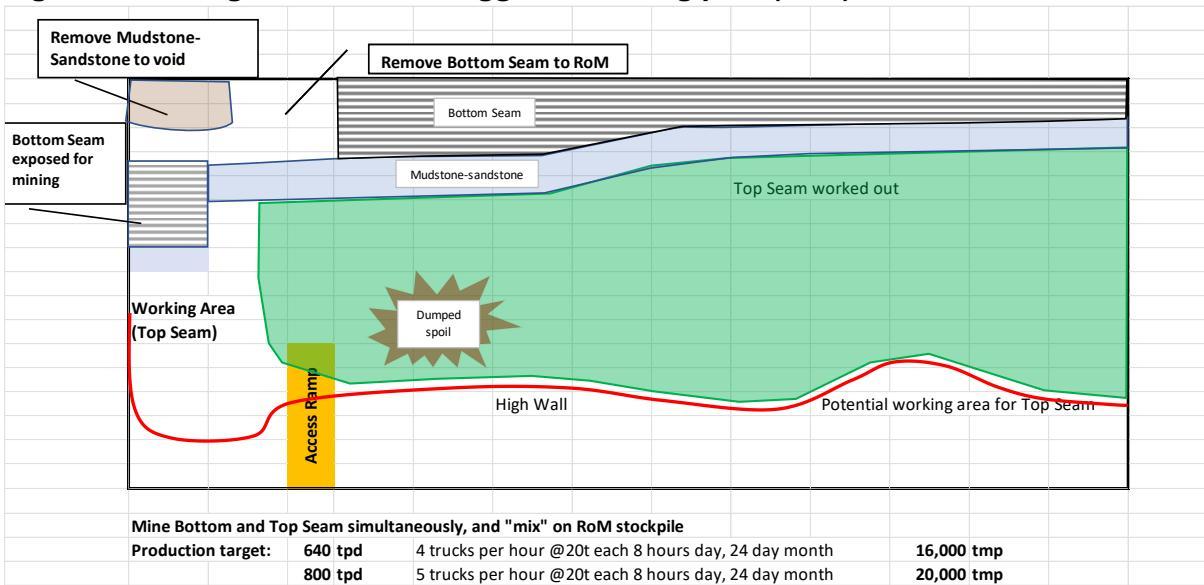
Figure 3 Working situation and suggested mining plan (Plan)

One of the reasons for the focusing on the Top Seam is that the Inter-burden between the seams is very hard to remove using the excavator but in the pit floor it is possible to walk along the exposed Inter-burden and Bottom Seam. See Figures 2, 3, 4 and 5 overleaf. It has been suggested to the Site staff that the working plan indicated in these Figures would allow for extraction of coal without any immediate need for overburden removal. It also allows for the simultaneous mining of Top and Bottom seams so the mine does not "High grade" its resources.

- f. Ensure a proper mining methodology is implemented so that inter-burden and overburden are dumped into the void created by mining and not transported out of the void and dumped beyond the Highwall

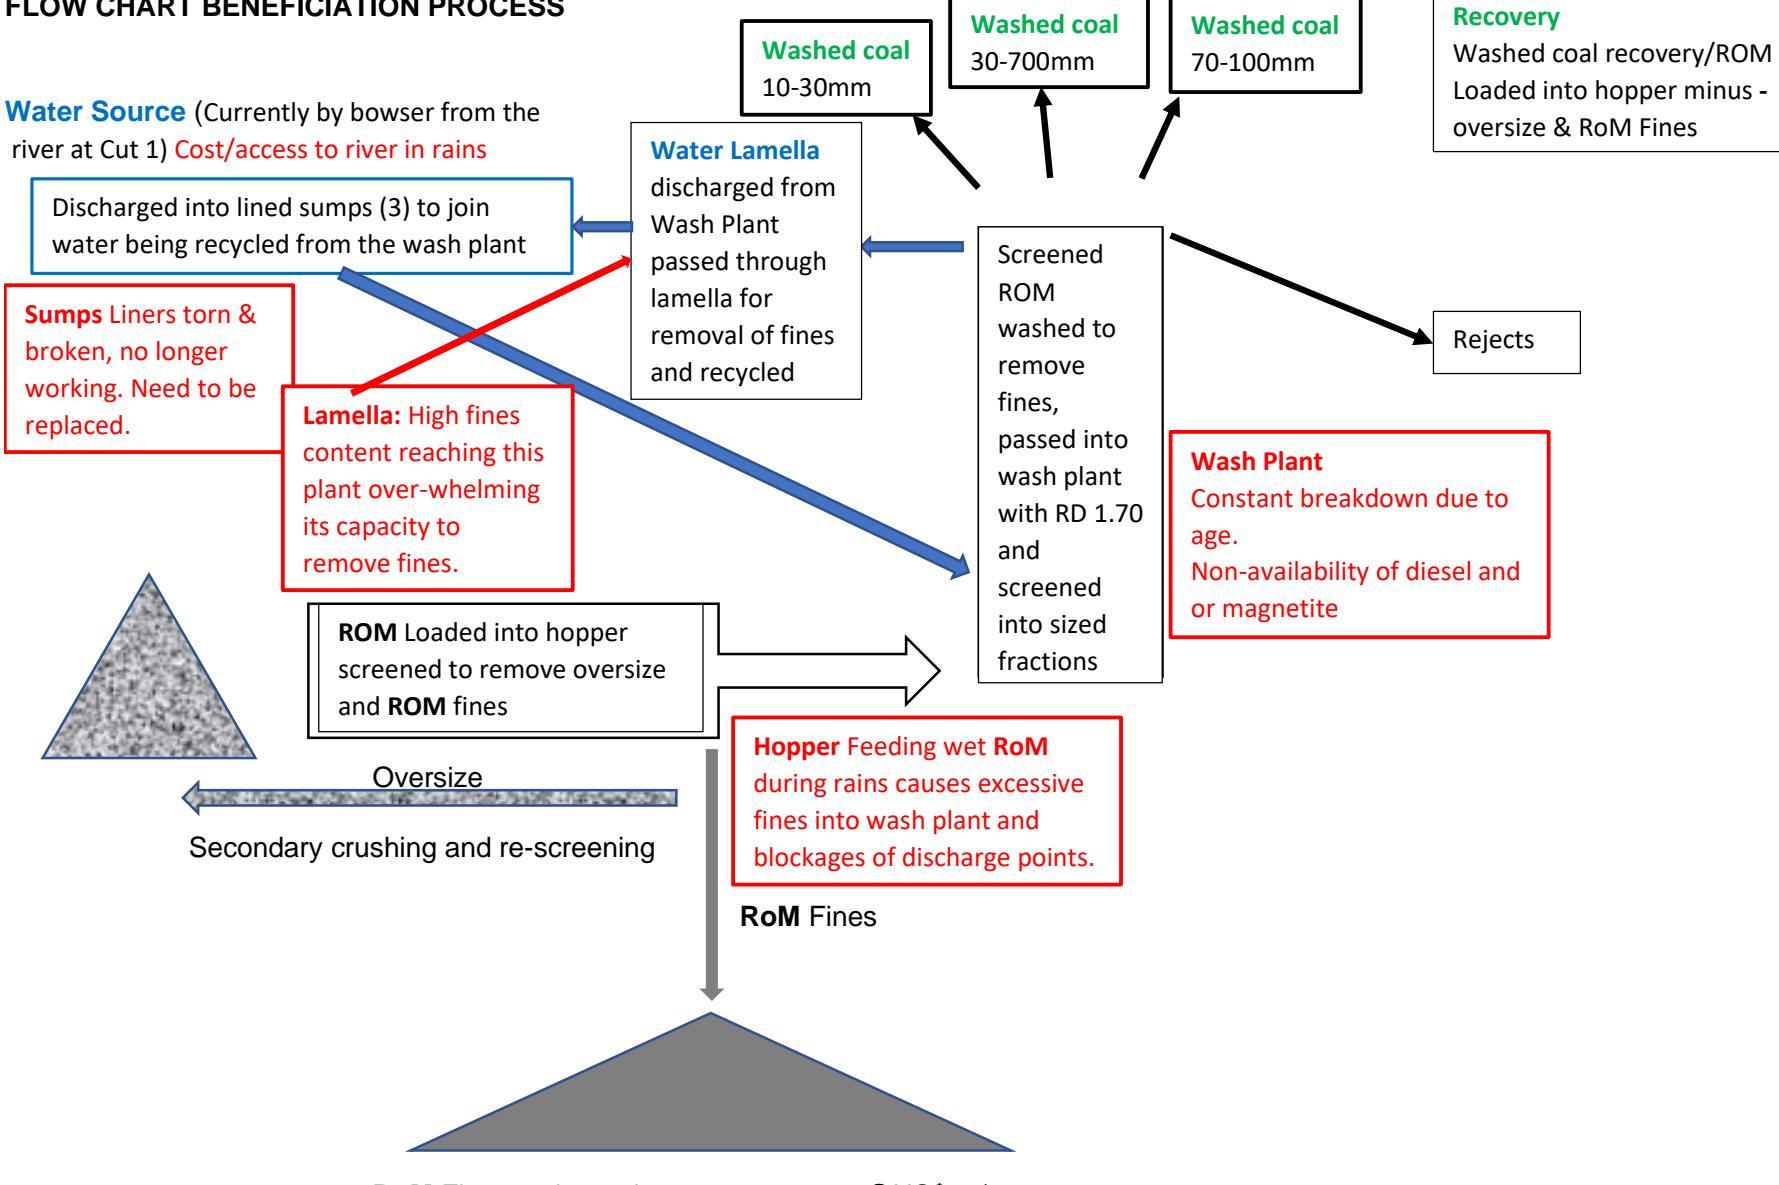
#### Figure 10: Wash Plant Flow Chart with Constraints (In red) FLOW CHART BENEFICIATION PROCESS

Figure 9 and 10 indicate the constraints on the Wash Plant which are fundamentally age, lack of key material, i.e. diesel, magnetite and occasionally water.

In the latter case there was an attempt some years ago to construct a pipeline from the water source at the river directly to feed the Settling Ponds from which the water is re-cycled back into the Wash Plant. The supply of water is a critical aspect of the Washing Plant and it is currently supplied by a water bowser at some expense. We tried to obtain clarity as to why the pipeline did not work and understand that water did not issue from the pipe at the Settlement Ponds. A brief conversation with a colleague in the water supply industry regarding this implies that an inadequate pump may have been the cause (the water has to be raised approximately 40m from the river to the ponds).

As mentioned above we understand that the cost of the supply of water via the bowsering set up is maybe not as cost effective as pumping and would suggest that alternatives be considered.

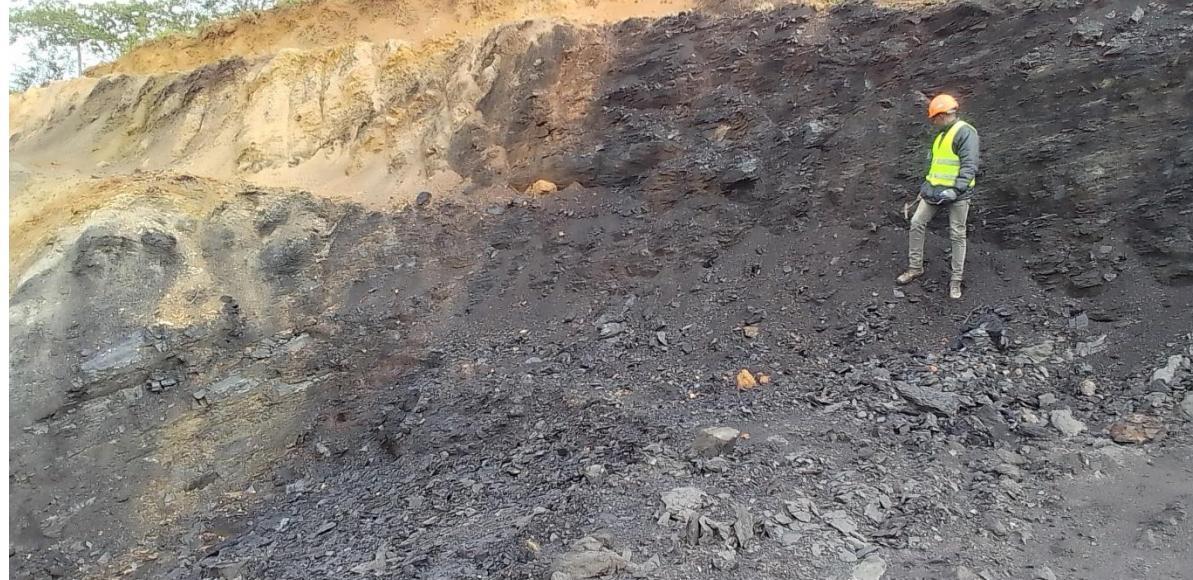
What was observed from the first site visit is that in the north-western corner of Cut 2, where operations are being currently undertaken, there appears, in the high wall, to be some sort of structural disturbance which was interpret as a minor fold (like a crease in towel!) which has doubled the thickness of the coal seam in that area.

Cut 2 North western end of the face working area. Top Seam

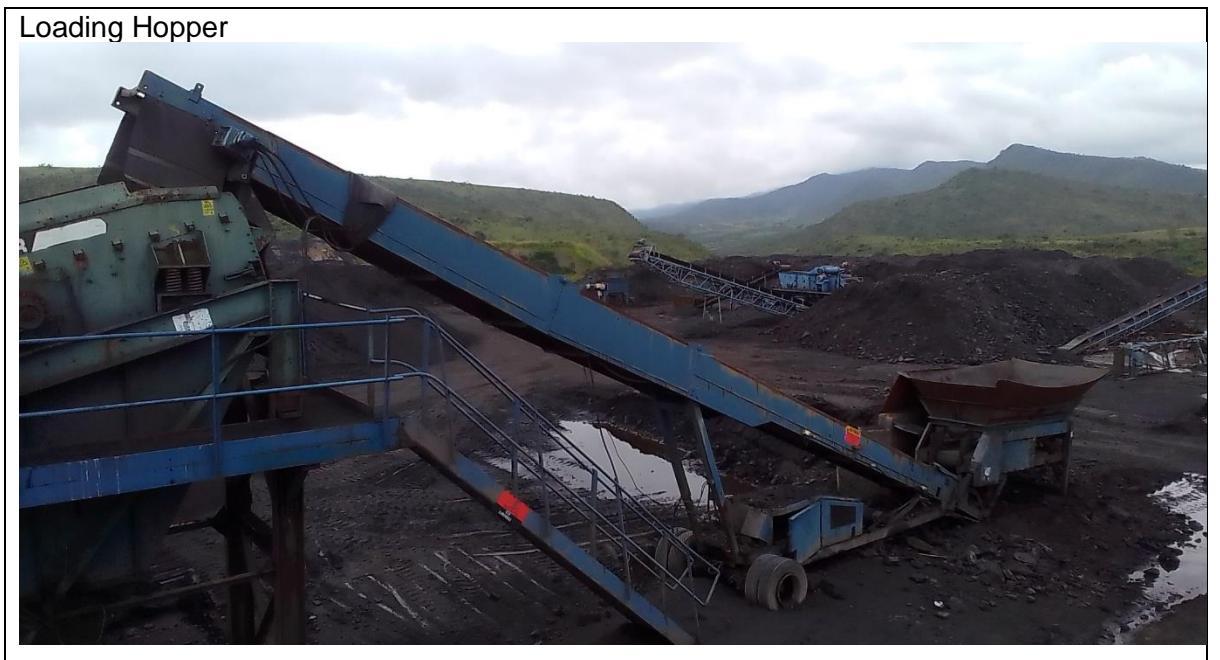
Oversize screened out
