Notes on a site visit to operations 27<sup>th</sup> February to 3<sup>rd</sup> March 2023 by A. Golding, B.Sc. Hons Geology 400036/96, Pr. Nat. Sci., M.S.A.I.E.G., FGSL, FGSSA.

#### Introduction.

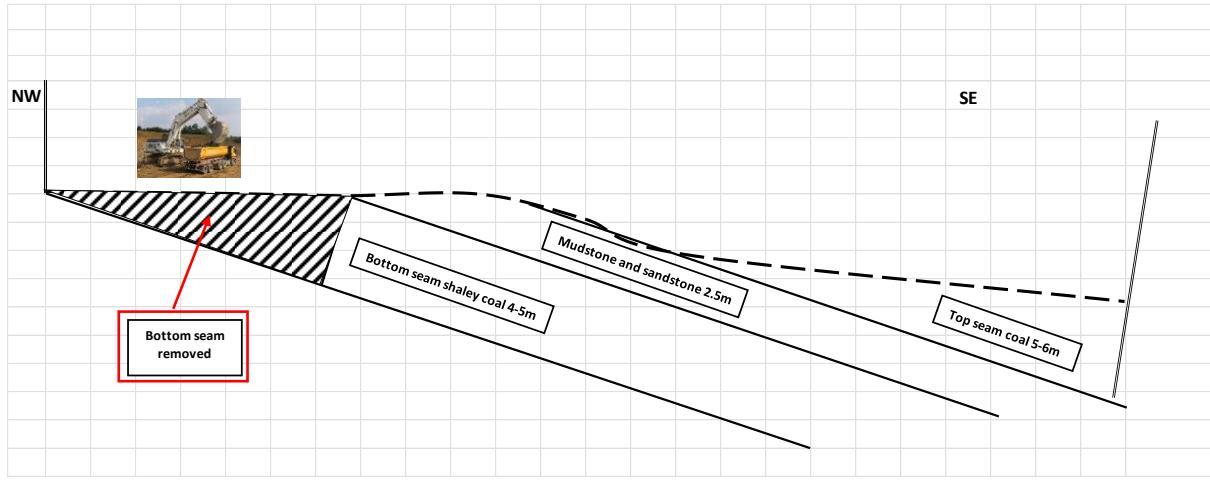
## Figure 4 Current situation and suggested mining plan (Section)

One of the reasons for the focusing on the Top Seam is that the Inter-burden between the seams is very hard to remove using the excavator but in the pit floor it is possible to walk along the exposed Inter-burden and Bottom Seam. See Figures 2, 3, 4 and 5 overleaf. It has been suggested to the Site staff that the working plan indicated in these Figures would allow for extraction of coal without any immediate need for overburden removal. It also allows for the simultaneous mining of Top and Bottom seams so the mine does not "High grade" its resources.

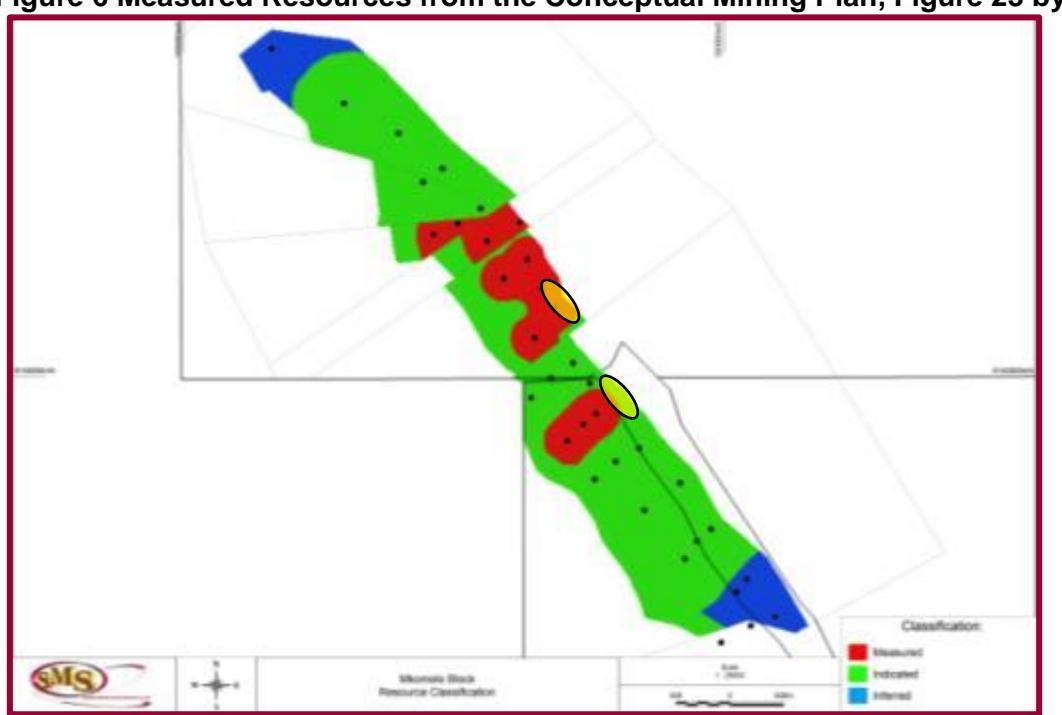
Figure 6 Measured Resources from the Conceptual Mining Plan, Figure 23 by SMS

Following the initial visit in September 2022 it was indicated that they will be shortly constrained to the NW by a water course but the area the SE could be expanded for approximately 100m to another water course and beyond. Reviewing maps, see Figure 6 below, it became apparent that by extrapolating the alignment of the Low Wall of Cuts 1 and 2, which form a straight line, that there was a likelihood that coal would sub-or outcrop between the two Cuts beyond the previously mentioned stream. Physical inspection of the Cut 2 operations in its south west corner indicated that it only terminates at a track running NNW-SSE and all parties (AG/JS/EE/DG) agreed that there was no reason not to continue mining in a SE direction and provide a diversion for the track.

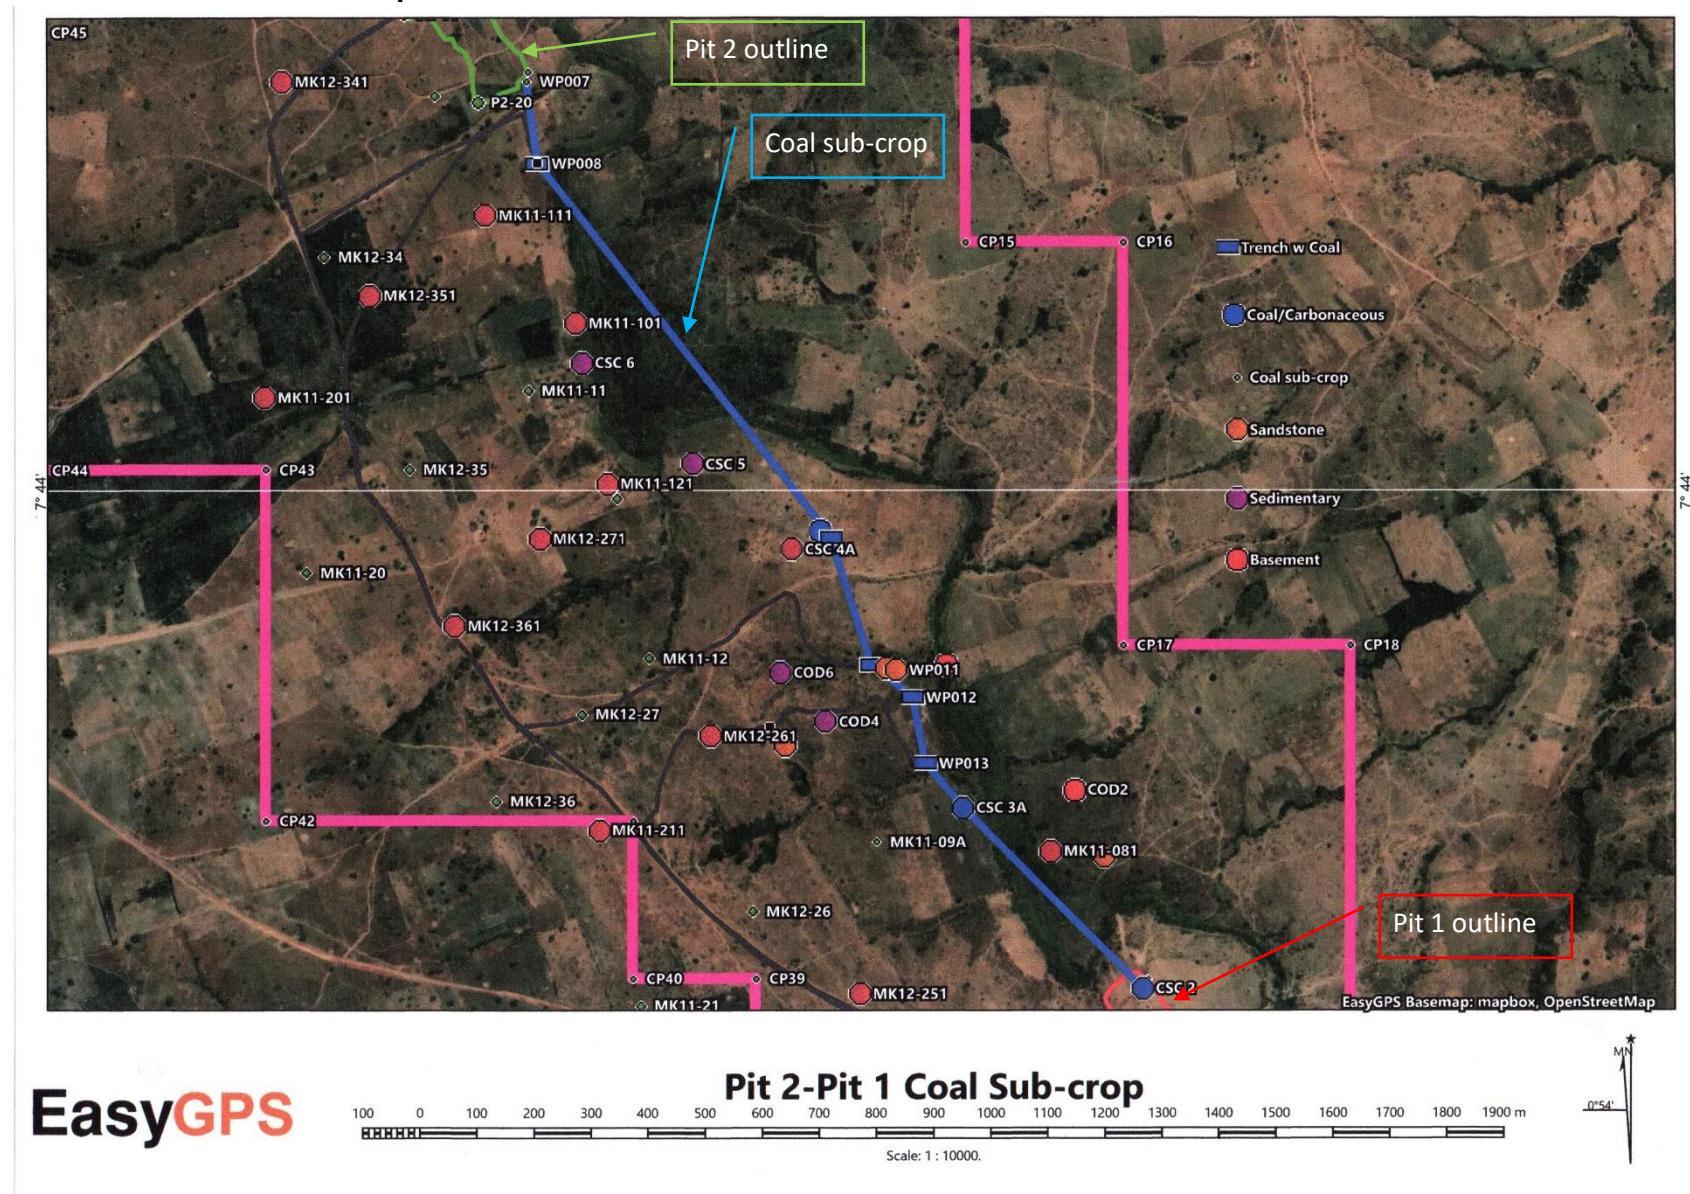
Figure 7 Locations of coal sub-crops between Pits 2 and 1

Following the September visit, and working with Geologist Said, the data from the boreholes between Cut 1 and 2 was extrapolated to surface using the observed dip of 24 degrees. Mapping and trial pitting was undertaken at or around these locations. This exposed multiple coal sub-crops in trial pits and historical trial pits with coal. See Figure 7 overleaf.

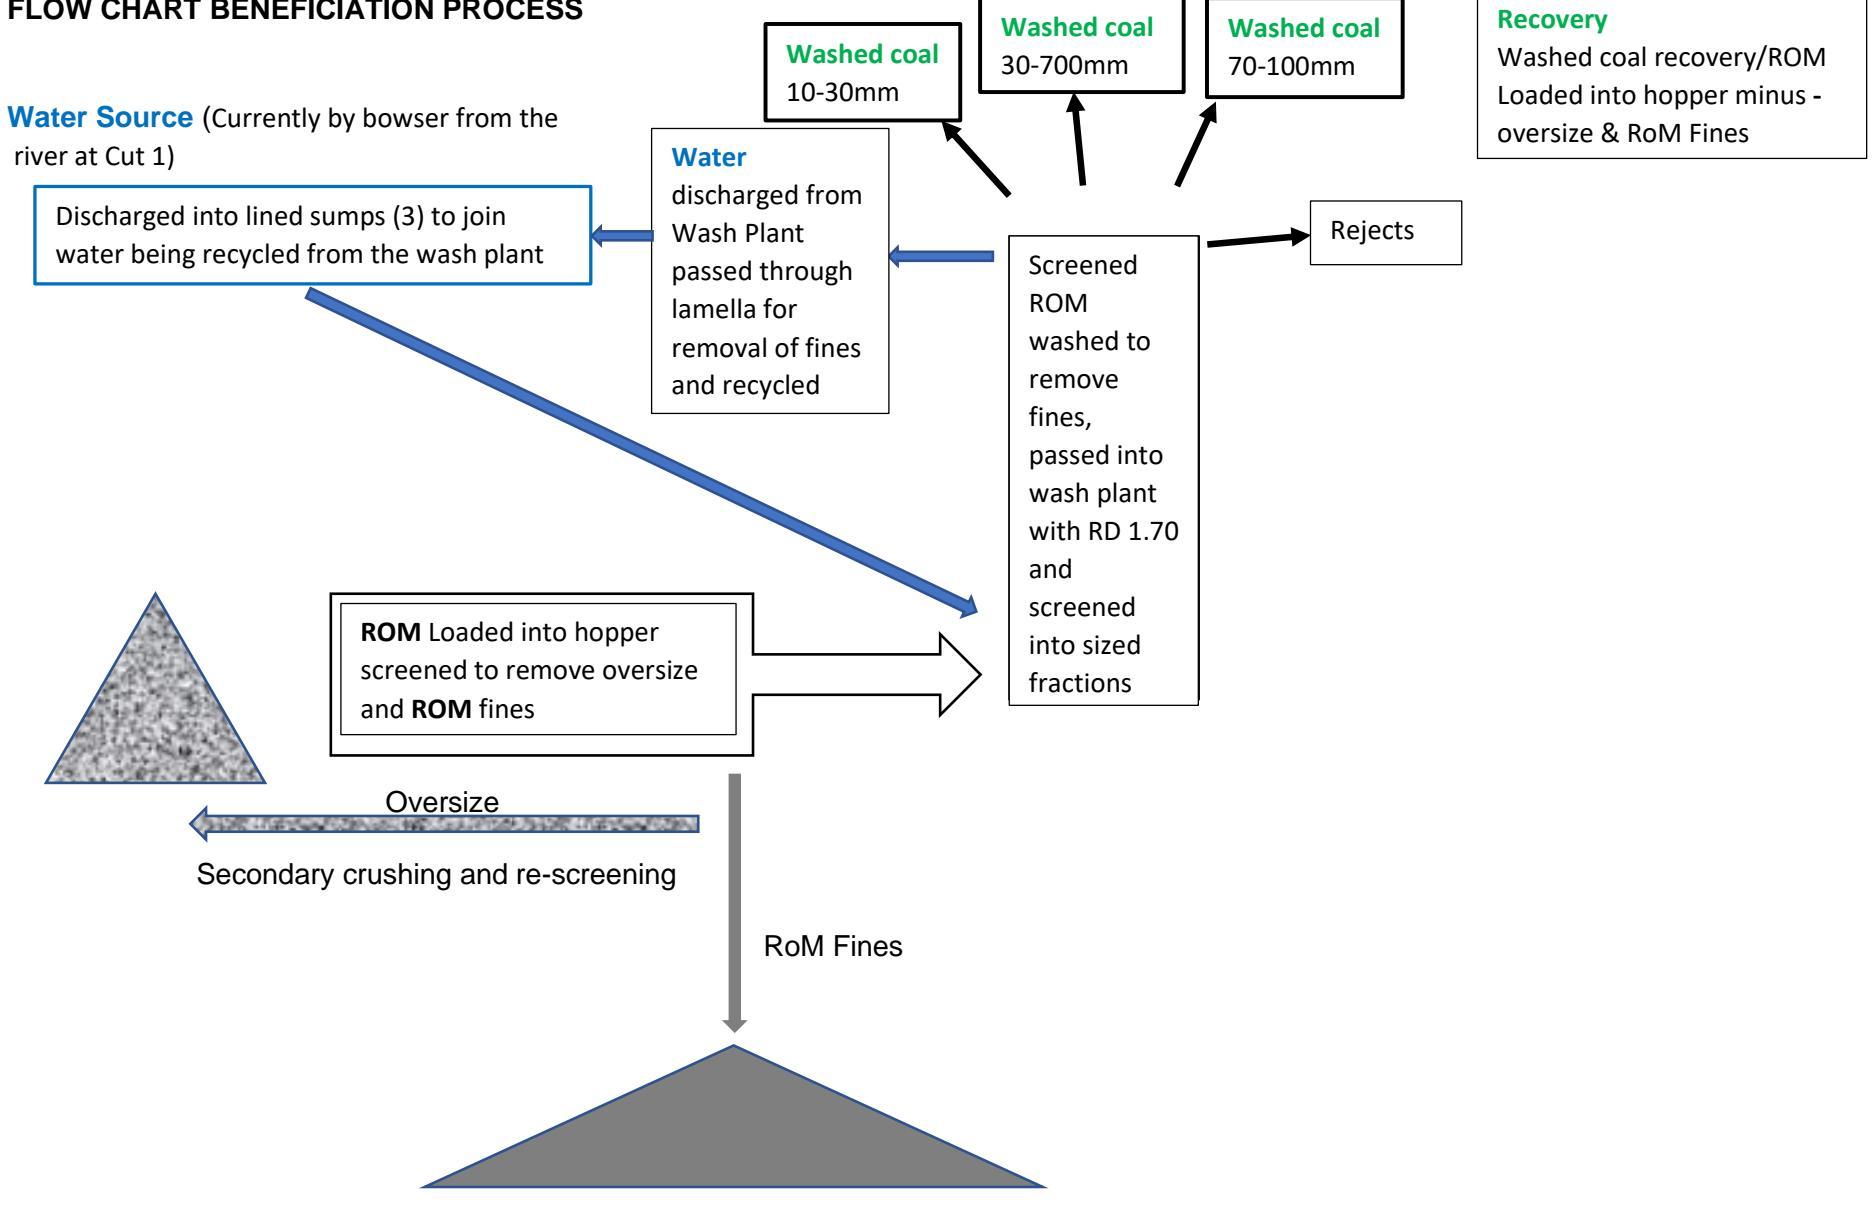
# Figure 9: Wash Plant Flow Chart FLOW CHART BENEFICIATION PROCESS

During this visit the Wash Plant was only operational for one day and was under repair (piping elbow had corroded and was patched). Time was spent becoming acquainted with the various processes at and supporting the Wash Plant i.e. hoppers, screening, water supply and settling ponds etc. The process is summarised overleaf in Figure 9. Constraints to the system, as noted on site and described by staff are indicated in Figure 10.

Figure 9 and 10 indicate the constraints on the Wash Plant which are fundamentally age, lack of key material, i.e. diesel, magnetite and occasionally water.

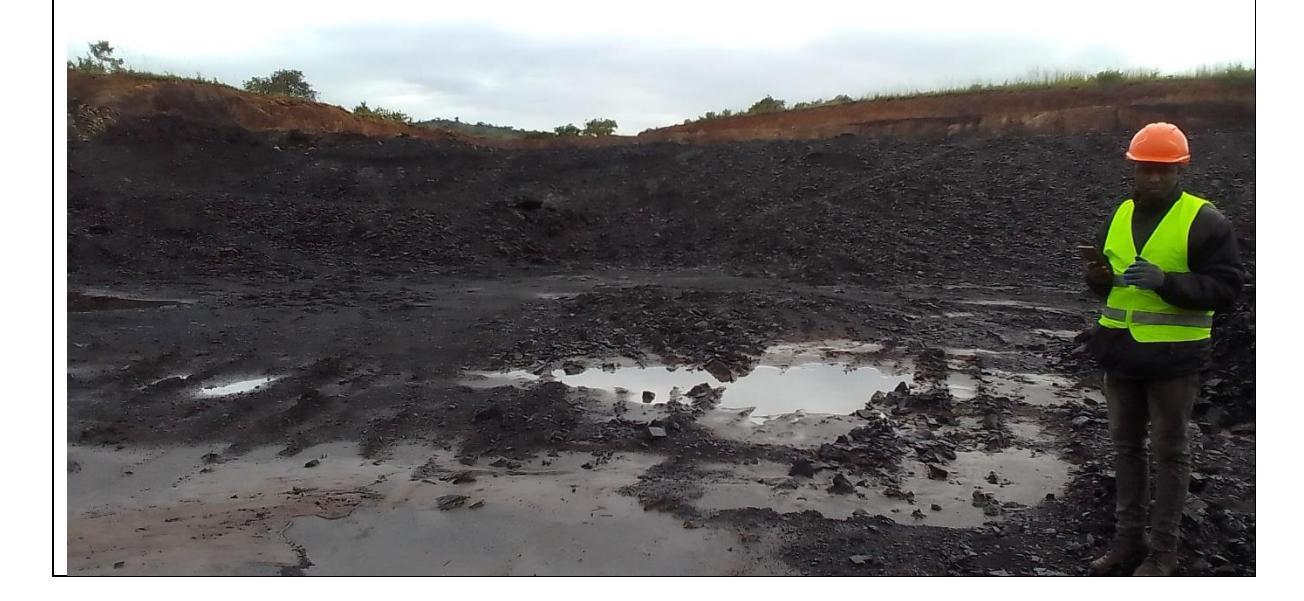
Cut 2 North western end of the face working area. Top Seam

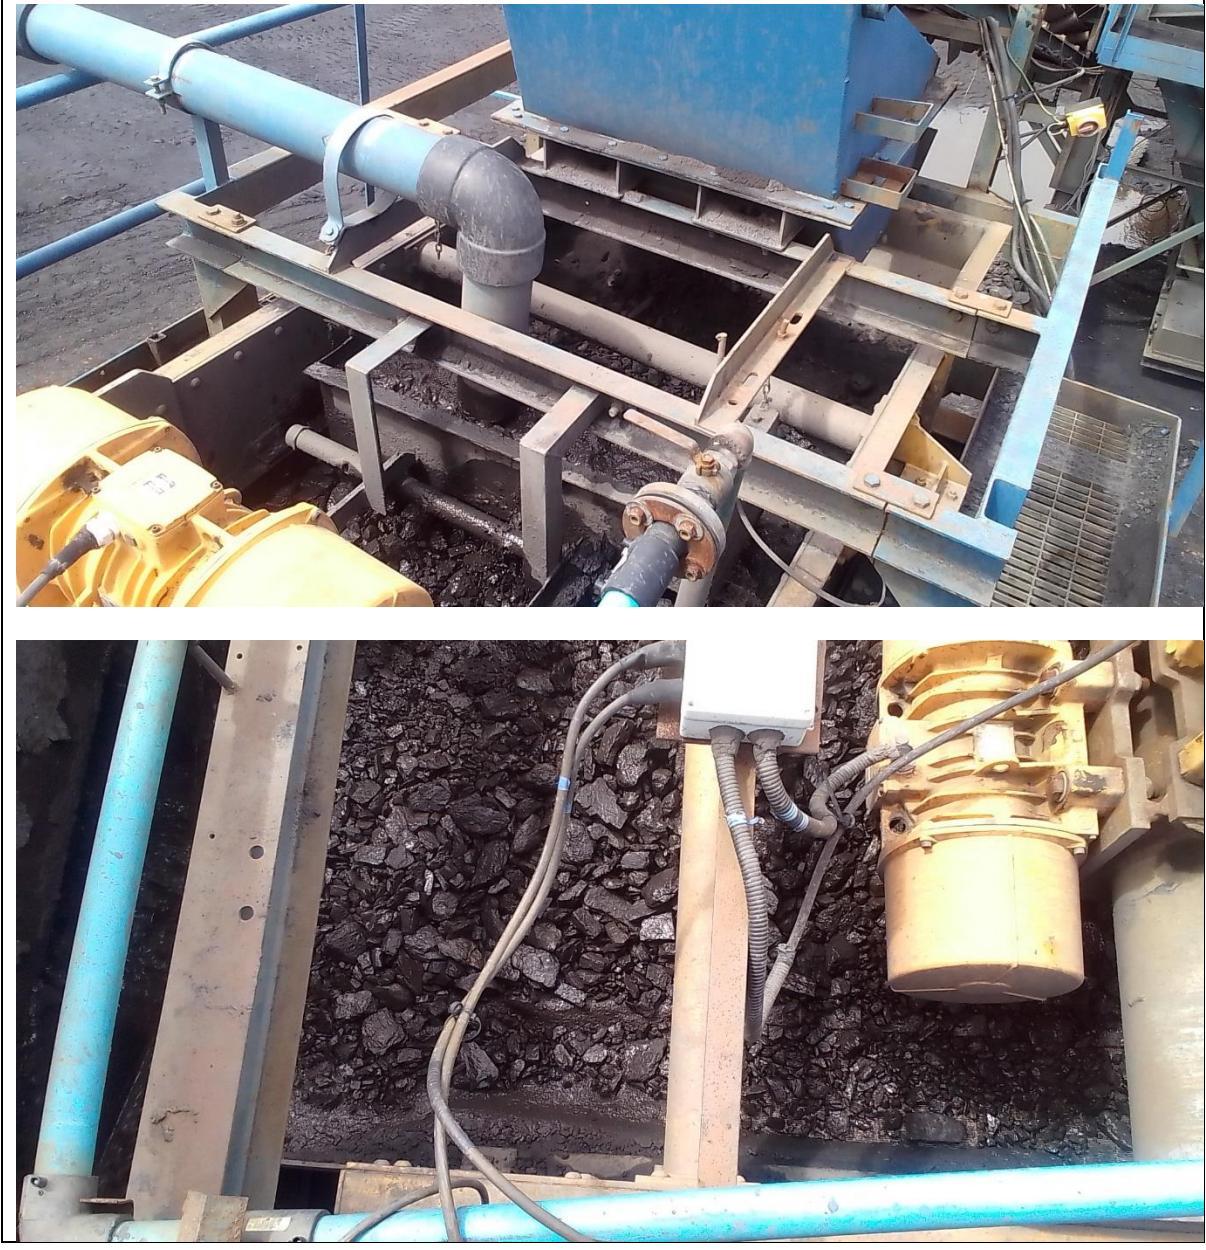
Feed into Wash Plant, very clayey as wet conditions are not allowing the fines to be screened out
